#### CASE STUDY – CORROSION MONITORING IN MARINE ENVIROMENT IN CROATIA

Prof. Dubravka Bjegovic, Ph.D., Faculty of Civil Engineering, University of Zagreb Irina Stipanovic, B.Sc.C.E., Faculty of Civil Engineering, University of Zagreb Marijan Skazlic, M.Sc.C.E., Faculty of Civil Engineering, University of Zagreb Kajo Feric, B.Sc.C.E., Croatian Institute of Civil Engineering, Center Split Ivo Barbalic, B.Sc.C.E., Croatian Institute of Civil Engineering, Center Split

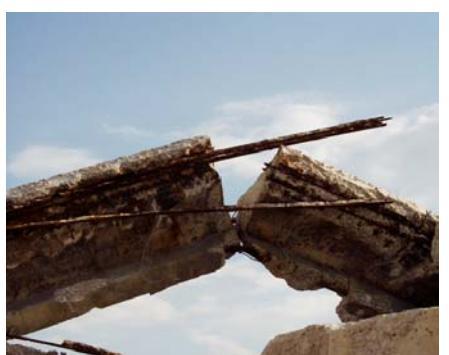
On the dock construction elements, which were demounted and pulled out from the sea, primarily a visual inspection was done (Fig.3-6). Based on this visual inspection it was concluded that the main beams of the span structure are in the critical state of damage (Fig.3-4), and no further testings were needed to prove usability of these elements. The columns of the tested dock were completely covered with the shells (Fig.5-6), and on some places concrete cover was destroyed by the reinforcement corrosion (Fig.6).

Figure 3. Span structure (T-beams)

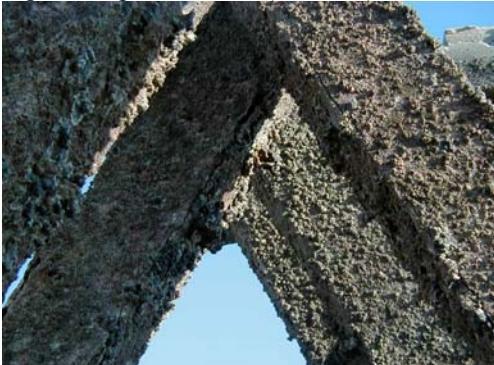
Figure 5. Columns of the tested deck covered with shells

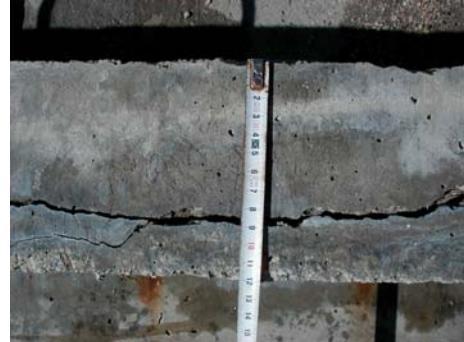
Figure 4. Cracks on the span beam

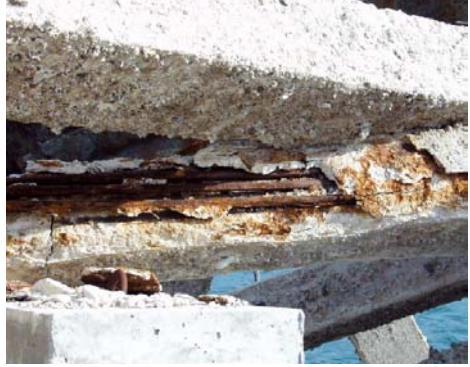
Figure 6. Columns with corrosion damage

On the base of visual inspection and laboratory tests the evaluation of the structure degradation level was given. It was obvious that structure was not enough qualitative designed and built, and above that the structure was exposed to the extremely agressive environment. Spalling of the concrete cover was visible on many places on the span beams, and also significant corrosion damages of the reinforcement. This damage type belongs to the critical grade and implies a indispensable intervention.

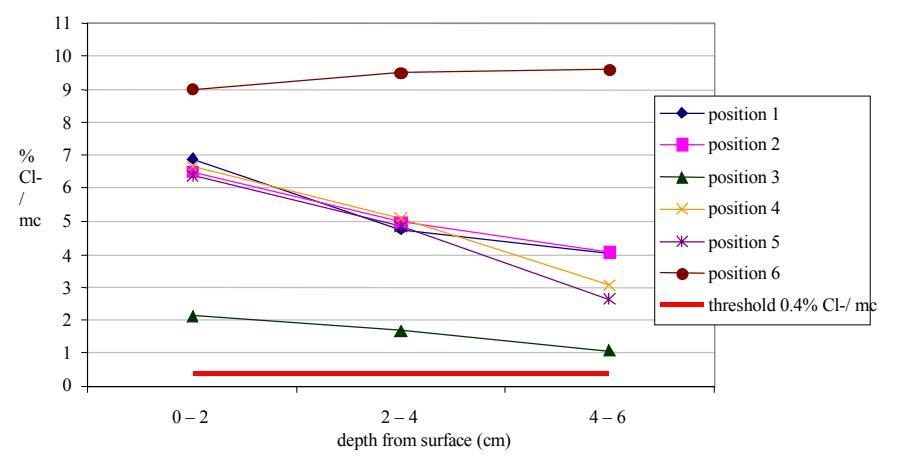
Figure 7. Chloride profile through the depth of the concrete

The chemical tests on drilled concrete cores showed that the concrete was heavily contamined by chlorides to a depth much deeper than the reinforcement position. The chloride content was multiple greater than the threshold of 0.4% by weight of cement. Values of pH factor were bigger than 12 on all tested specimens.

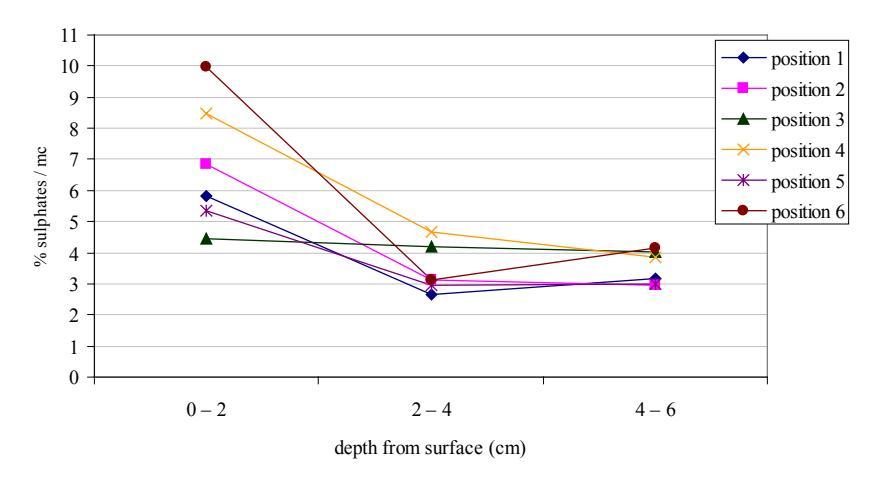
Figure 8. Sulphate profile through the depth of the concrete

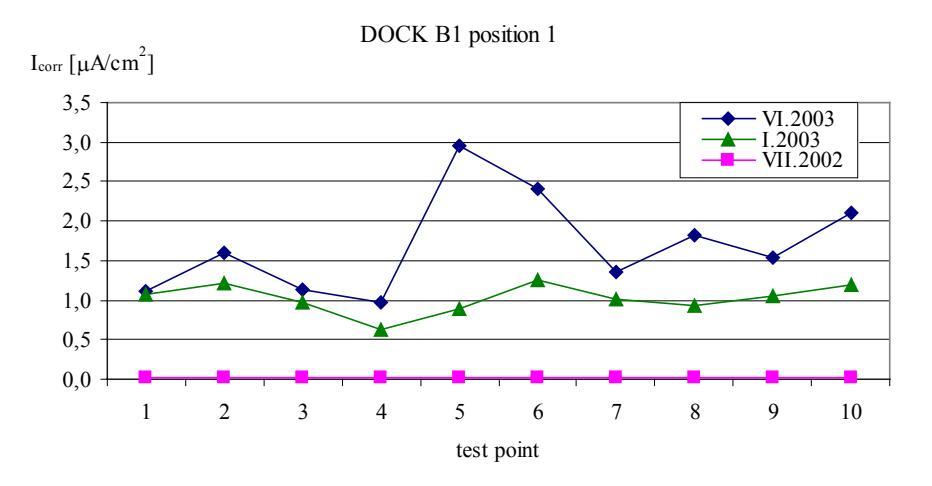
Figure 15. Corrosion current readings on position 1, dock B1

- it is obvious that the MCI<sup>®</sup> (dock F) has lowered the corrosion current;
- according Clear estimation: no corrosion damage is expected on dock F and on dock B1 possible corrosion damage in next 10 to 15 years;

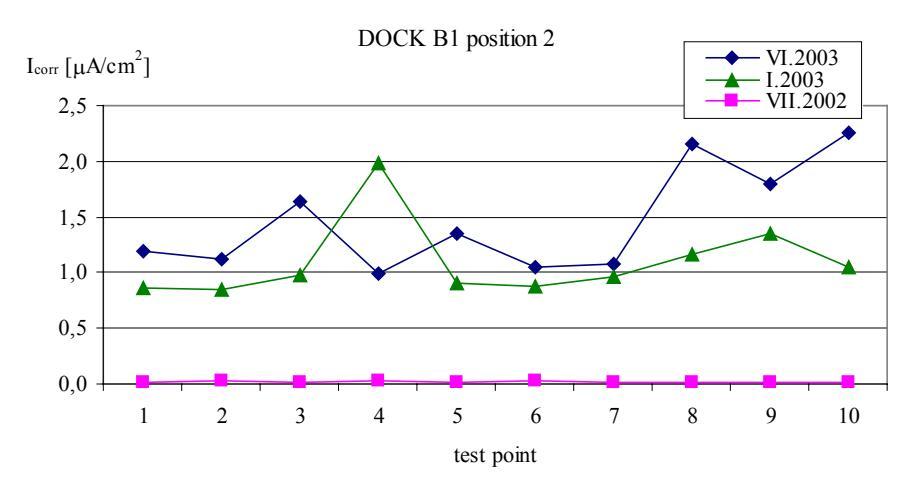
Figure 16. Corrosion current readings on position 2, dock B1

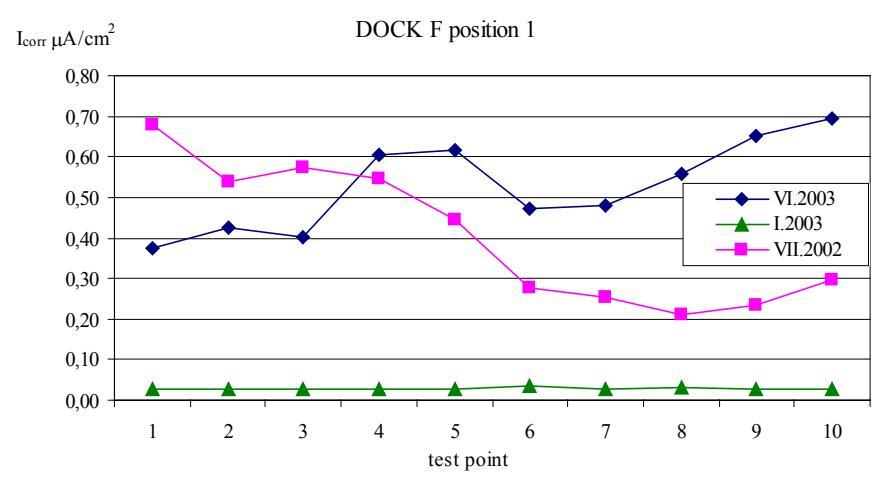
Figure 23. Corrosion current readings on position 1, dock F

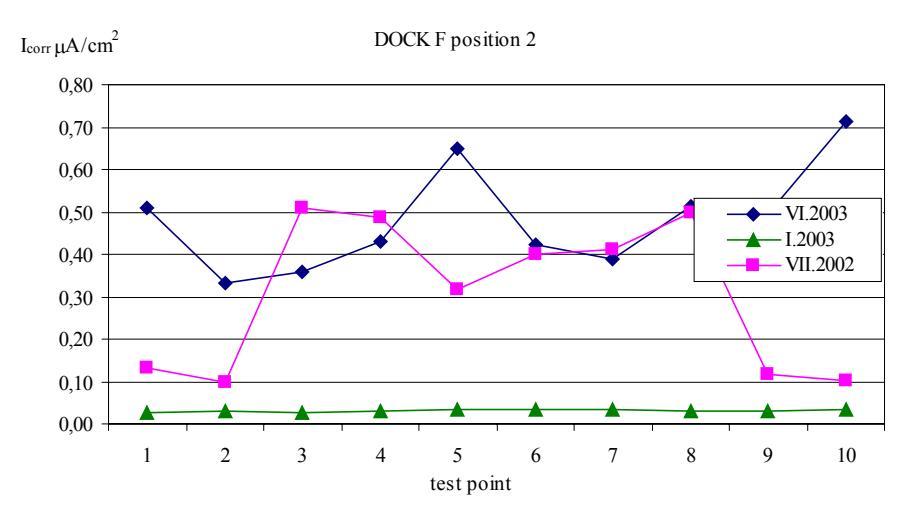
Figure 24. Corrosion current readings on position 2, dock F
