#### CASE STUDY – CORROSION MONITORING IN MARINE ENVIROMENT IN CROATIA

Prof. Dubravka Bjegovic, Ph.D., Faculty of Civil Engineering, University of Zagreb Irina Stipanovic, B.Sc.C.E., Faculty of Civil Engineering, University of Zagreb Marijan Skazlic, M.Sc.C.E., Faculty of Civil Engineering, University of Zagreb Kajo Feric, B.Sc.C.E., Croatian Institute of Civil Engineering, Center Split Ivo Barbalic, B.Sc.C.E., Croatian Institute of Civil Engineering, Center Split

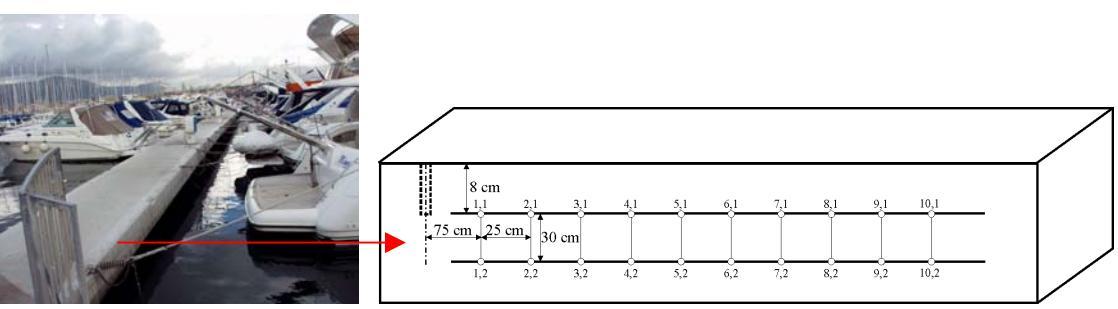
Dock B1 was built of the concrete quality C40. Span beams are prestressed prefabricated concrete elements, with U shape in cross section (Fig.9). Concrete surface was done without any protection. On Figure 13 the position of dock B1 is visible and that the first span beam is exposed to sea splashing. Schematic view of test points is are shown on the Fig. 14.

Figure 13. Dock B1.

Figure 14. Schematic view of test points.

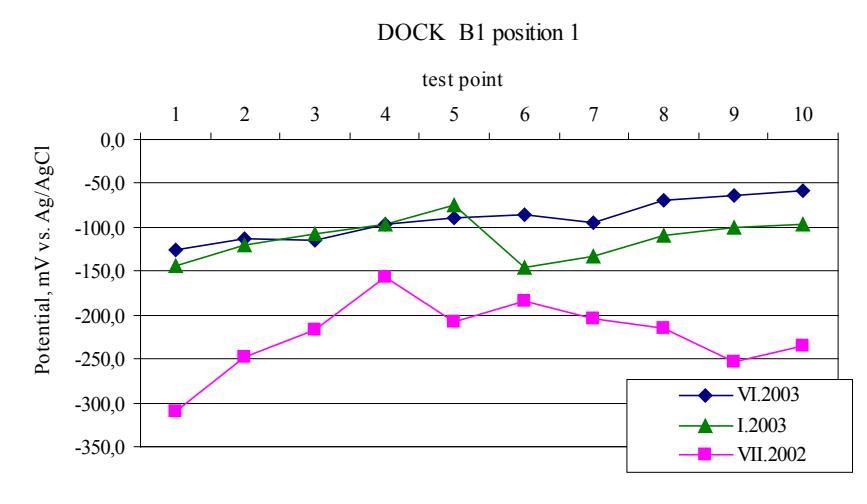
Figure 17. Potential readings on position 1, dock B1

- it is obvious that the MCI<sup>®</sup> (dock F) has lowered the corrosion current;
- according Clear estimation: no corrosion damage is expected on dock F and on dock B1 possible corrosion damage in next 10 to 15 years;

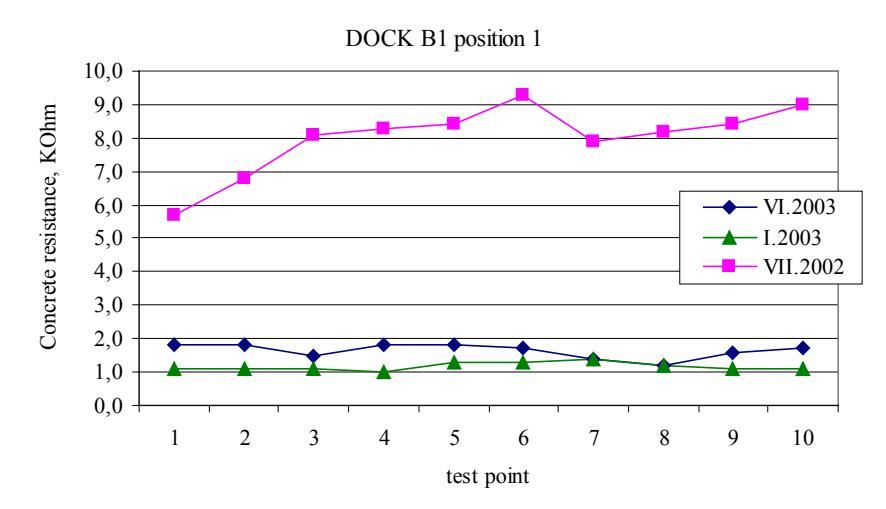
Figure 19. Concrete resistance readings on position 1, dock B1

- concrete resistance will be used as a control measuring; resistance is influenced by weather conditions, humidity and temperature;
- the galvanostatic pulse measurements are providing a momentary value of actualy corrosion stage, which significantly depend on actual concrete conditions (humidity, temperature, pH-value, chloride content) [6];
